## Topic: RTK Pan Gasket Thickness Improvement

### PRODUCT IMPROVEMENT: TRANSMISSION GASKET THICKNESS

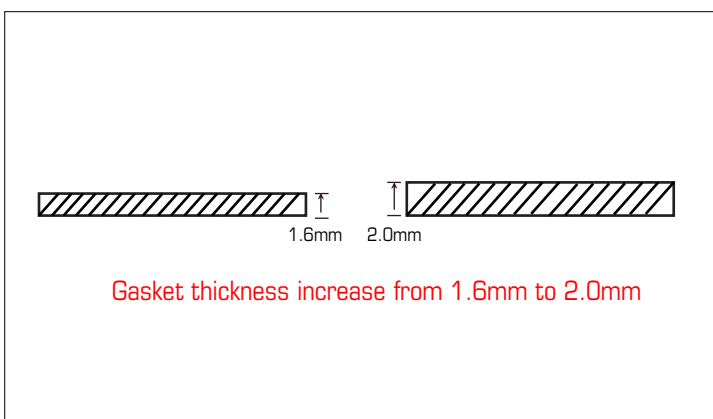
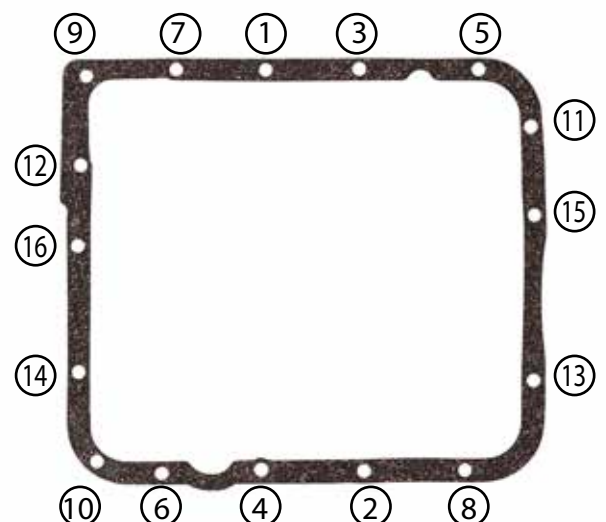
Following this process we identified the potential risk of damage to the pan gasket if the wrong tightening force and sequence was applied causing the gasket to split on one end and therefore a fluid leak would occur. We have increased the thickness of our gaskets to 2.0mm ensuring potential risk is further minimized.

**Example of tightening torque sequence**  
TIGHTENING TORQUE FOR SCREWS = 12 Nm  
TIGHTEN SCREWS IN ORDER **1 THROUGH 16**  
AS SHOWN IN DIAGRAM

The new gasket will be more forgiving in case of over tightening, and it is strongly suggested that the manufacturers torque specs are followed to ensure no fluid leaks after installation.

- Ensure the transmission pan has no damage and is clean prior to fitting it back.
- Ensure the correct tightening sequence and torque is applied to ensure even sealing pressure at each pressure point.
- Fitment Guides that include tightening sequences can be found on our website here:  
[www.rycofilters.com.au/products/transmission](http://www.rycofilters.com.au/products/transmission)
