SUITS: Holden, Hyundai, Kia & Toyota
TRANSMISSION CODES: A340E/F, A343F, A30-40LE & U340E/F

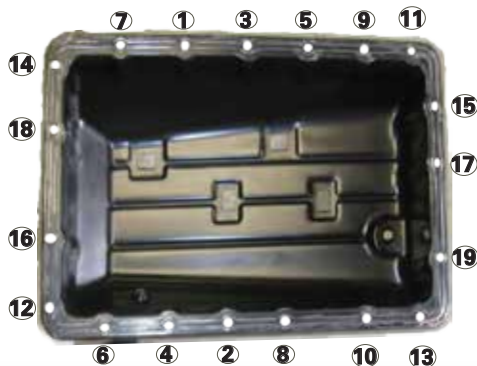
TIGHTENING TORQUE FOR SCREWS = 7 to 8 Nm
TIGHTEN SCREWS IN ORDER 1 THROUGH 19
AS SHOWN IN DIAGRAM

- 13) Fit the pan to the transmission case and tighten the bolts by hand starting with the corners, then utilise a torque wrench to tighten bolts up to 7-8 Nm in the sequence shown in diagram below.

- * **Not following the recommended tightening torque and sequence may lead to transmission oil leaks and damage to the gasket. Tightening with force greater than 8 Nm can squash and crack gasket, where as not tightening enough will lead to oil leakage.**
